An Innovative Application for Nonwoven Geotextiles

M BINDRA, Permathene Ltd, Auckland, New Zealand

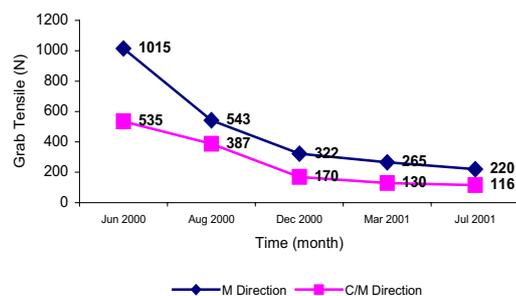
Figure 1. ETCART Site Grab Tensile Strength vs Time

The ETCART project was installed in May - June 2000. The laboratory tests were conducted on samples retrieved from actual ETCART sites and recorded in Table 1. The results showed that about 37 % strength loss after 60 days of exposure, but the material was in tact and not broken down. The strength loss was seen and it was about 78 % in 13 months with no signage of breaking of the material. The area was partially covered with shrubs. This was quite convincing as NZ being a country prone to very strong UV, the results were satisfying. In summer, New Zealand typically receives around 50 % more UV than Southern Germany.

As seen from the Figure 1, the strength decreases @ 37 % in 2 months, 68 % in 6 months, 75 % in 9 months and finally 78 % in 13 months. After 9 months of exposure, the strength loss was only 3 % in 4 months, which concludes that there will be not much further loss of strength before the geotextile fully breaks down.

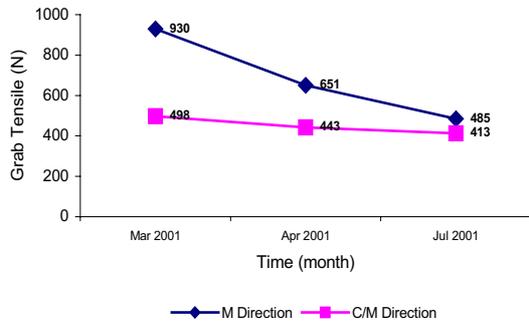
Figure 2. Mayfair Site Grab Tensile Strength vs Time

The tests conducted on samples retrieved from the Mayfair Village project site were of concern as shown in the Table 2. These samples were taken from the areas badly damaged / broken down where the soil was exposed. The installation for Mayfair project was done in October 2000. As seen from the figure 2, about 80 % strength loss after 60 days of exposure was observed and further 12 % strength loss in 90 days, thus a total loss of 92 % in 5 months and finally 93.5 % in 9 months. After 6 weeks of installation, it was noted that the material had broken down in most areas. The initial reasons discussed with the client’s engineer were either the geotextile was tightly stretched in some areas or not being placed properly on the ground or chemical attack. It was unusual for the 135 gsm fabric to deteriorate in such a short span as compared with the ETCART project.

Upon final analysis of the Mayfair job and contrary to laboratory analysis, which indicated adequate carbon content, we concluded that the problem here was one of carbon dispersion. For adequate UV protection of an exposed fabric, it is imperative that carbon be dispersed evenly through out the polymer. The Mayfair job had uneven carbon dispersion and this resulted in an early break down of the fabric in some areas. The exposed areas were treated with herbicide, which have stopped the growth of the weeds in those areas. On the whole, the installation of the geotextile has prevented surface erosion during the shrubs establishment period and also assisted in the suppression of the weeds.

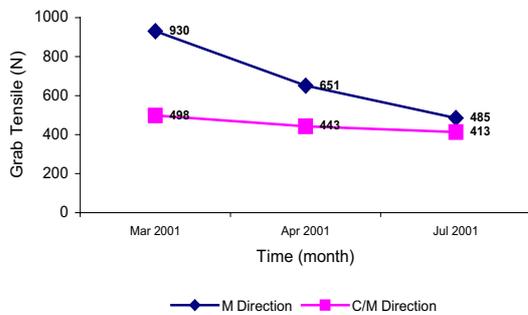
Figure 3. Grab Tensile Strength vs Time for Sample without Roundup Herbicide

In March 2001, we took the virgin sample of the geotextile and sprayed with isopropylamine liquid herbicide (Roundup) on the top. The tests were conducted on both the samples (Virgin and with roundup) and the results are shown in Table 3 and 4 respectively. As seen from the figure 3 and 4 respectively, the strength loss was 20.5 % for virgin geotextile as compared to 23.5 % for chemically treated geotextile after 4 weeks of installation on a open leveled ground in a fully exposed conditions.

After 4 months, the tests were again conducted and the strength loss was 32.5 % for virgin geotextiles versus 37 % for chemically treated geotextile. Hence it was concluded that the herbicide spray has got no appreciable affect on the geotextile. The chemical may have been sprayed just prior to installation or even after the installation of the geotextile but will not affect the performance.

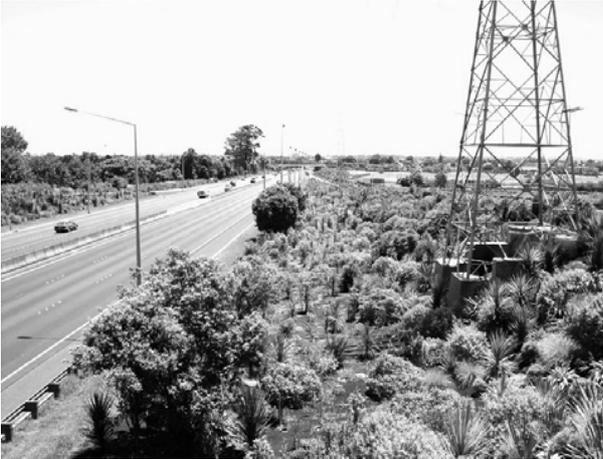
Stable Embankment with Fully Grown Vegetation – ETCART Project
