## Sand Filter

### High Strength Geotextile (Syntex®) Water Authority, Apia, Samoa

**Client: Samoa Water Authority**  
**Date: October 2000**

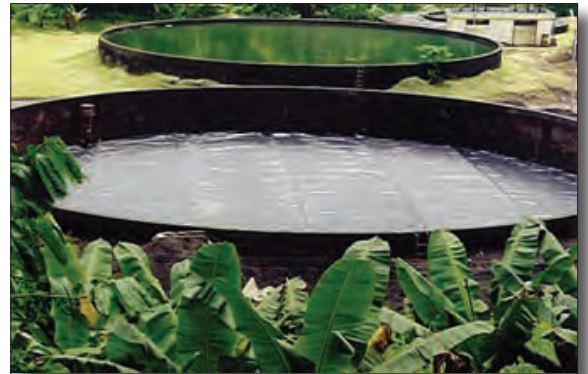
For rehabilitation of the filters, it was suggested by engineers to remove sand and wash it and prevent further infiltration of fine silt material into the lower gravel layers. To achieve this, Syntex GHS 35/35 high strength woven geotextile was recommended to be placed on top of the gravel layer because of its high strength and superior hydraulic properties.

Syntex GHS is manufactured in an ISO 9001 facility and tested by a GRI (Geosynthetics Research Institute) laboratory. In total, five Syntex sand filters of 28 meter diameter each were fabricated by Permathene Ltd in Auckland and installed at Alaoa treatment plant in Apia to prevent sand particles of < 0.15 mm infiltrating into the bottom gravel layer of the water treatment plant.

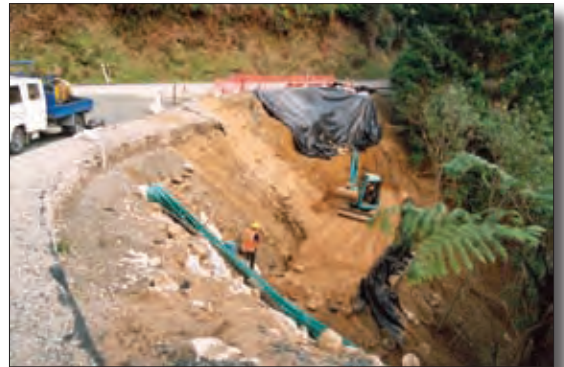
After thorough discussion with the Contractors, Syntex GHS 35/35 (35 kN x 35 kN) and GHS 70/70 (70 kN x 70 kN) High Strength Woven Geotextiles were approved for use in the construction of the Mechanical Stabilised Earth (MSE) wall.

The area was first graded and smoothed, removing any rocks and debris. Two layers of AP 65 aggregate was placed using Syntex GHS 70/70 geotextiles to a depth of 150 mm. Then the first layer of Syntex GHS 35/35 geotextile was placed.

Once backfill was placed to the height required by the design (600 mm), Syntex 2x2 was laid over the compacted Onekaka Schist Sandy soil. The sequence was repeated until the wall reached its total height of 6 m.

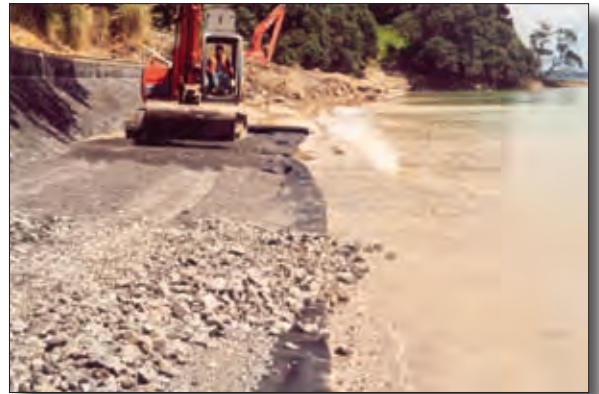
The contractor selected Syntex GHS 70/70 (70 kN x 70 kN) Woven High Strength Geotextiles based upon its excellent performance on similar projects.

Placement of the geotextile was made after the area was cleared and was placed directly over the sandy soil. 50 mm of GAP 40 fill was then placed over the geotextile and overlaid with 350 mm of GAP 100 using an 8 tonne digger. The result is that the site subgrade was successfully stabilised which allowed the movement of 22 Tonne trucks on this access road to do slip repair work.

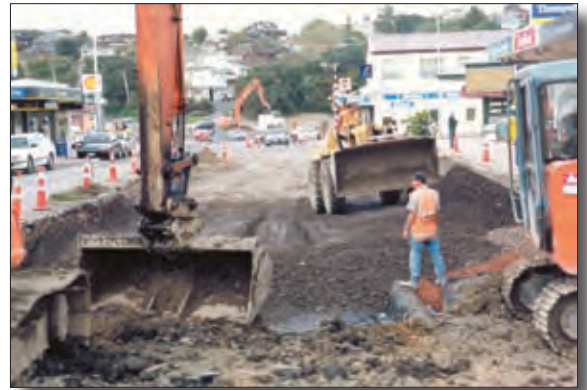
Subgrade was extremely weak with saturated fine grained silt and clayey soils with a CBR value less than 3. The consultant opted to install a lightweight nonwoven needlepunched geotextile on existing subgrade overlaid with GAP 60 to a depth of 600 mm. On top of this 150 mm of M4 was placed.

Syntex GNP A1 (Strength Class A) nonwoven, needlepunched, staple fibre geotextile was used as the lightweight subgrade separation fabric to improve bearing capacity.

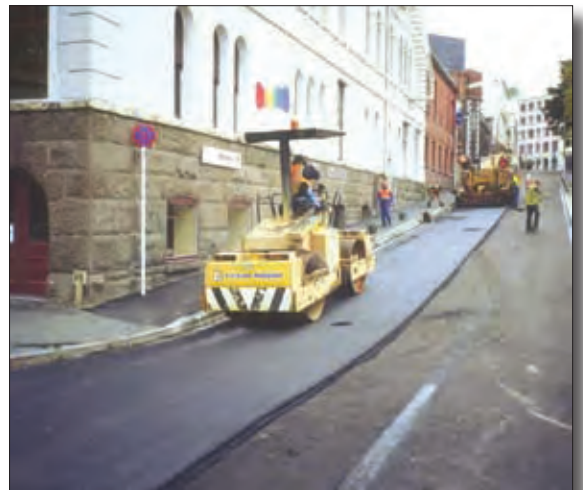
The contractor Fulton Hogan of Dunedin installed Pavedry asphalt overlay fabric with the calendered side up using an appropriate installation device. All the cracks (> 6.3 mm wide) were filled with an appropriate crack sealant and the tack coat was sprayed approximately 150 mm wider than the width of the paving fabric. All seams were overlapped 75 mm along roll edges and 150 mm at roll ends.

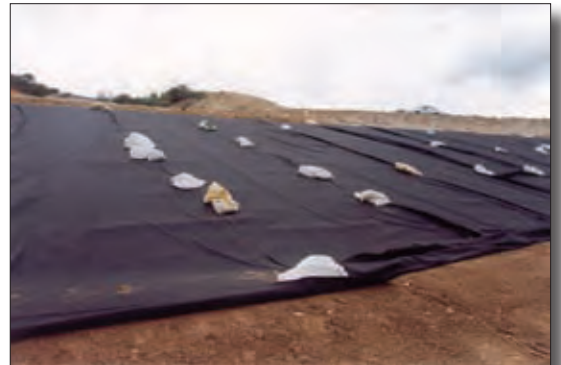
The scope of work also includes the construction of road crust protection works consisting of gabions filled with stone boulders and placed over Syntex GNP B1 (Strength Class B) nonwoven geotextile on slopes and apron.

The embankments will also be protected with Syntex GNP B1 covering and gabions. Syntex GNP B1 nonwoven geotextile was supplied by Permathene Ltd of New Zealand.

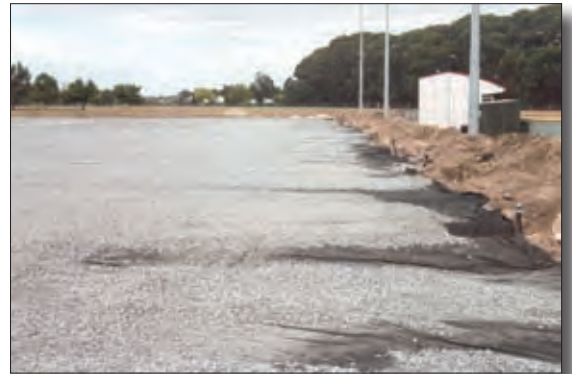
The total area of approximately 6000 m<sup>2</sup> was properly compacted and covered with Syntex GNP 115 before putting 150 mm of clean gravel drainage blanket overlaid with GAP 40 to a depth of 125 mm. After proper compaction, 25 mm of open graded asphalt was spread on the top before finally placing the Astro Turf on it.

By placing Syntex GNP 115, which is a light grade fabric, at the interface between the subbase and a soft subgrade, contamination was avoided and bearing capacity was improved.

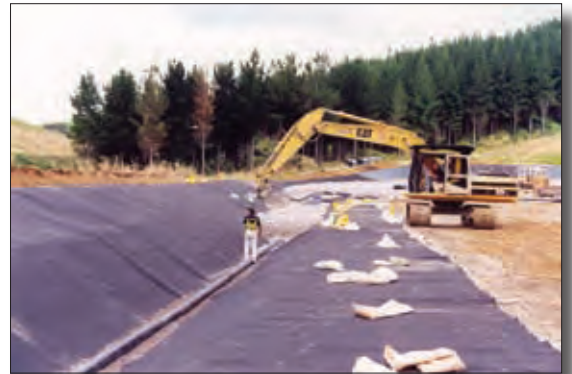
Syntex GNP E1 (Strength Class E) nonwoven geotextile was recommended by Permatherne to go on top of the 1.5mm HDPE liner. By virtue of its chemical composition, molecular structure and thermodynamic properties, polypropylene is one of the most resistant raw materials known today.

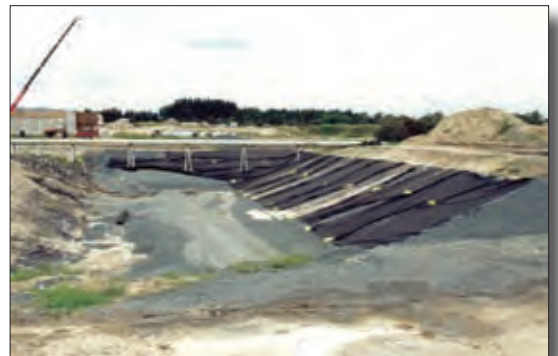
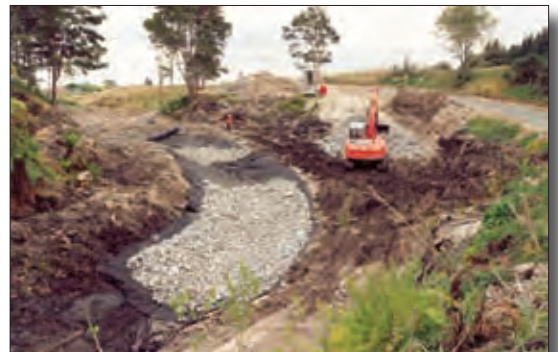
The laying of the 6 m wide stormwater channel and 2 m wide treated wastewater gully necessitated construction over a very soft swamp. Site investigations indicated the proposed subgrade was comprised of black topsoil with large rotting tree stumps and logs, underlain by extensive peat deposits. David Ward, Contracts Manager of Pemberton Construction Ltd, described the site as marshy and difficult to walk on. A 1 m deep "V Drain" was constructed and filled with metal. Syntex GNP D1 was laid on top of the metal, covered with 300-400 mm of rip rap (100-300 mm size aggregates) and levelled.

Syntex GNP D1 acts as a "separation" layer stopping the rip rap material from pushing down into the soft wet subgrade and preventing mud from contaminating the clean aggregate. This gives a more stable, wearing and sturdy solution for the drainage problems.

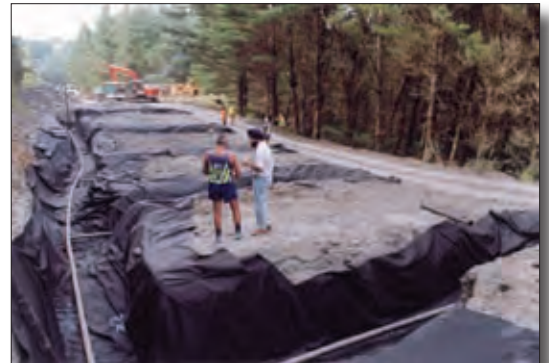
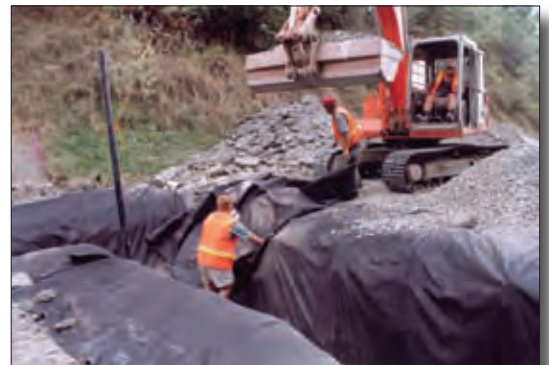
This contract was let to Fulton Hogan in December 1998 and is expected to be completed by June 1999. In order to stabilise the highway, various sections were dug out by the contractor at the unstable areas immediately north of the main slip sites and the drainage pipes were later installed, covered with the drainage aggregate wrapped in Syntex GNP B1 (Strength Class B) nonwoven geotextiles. The typical average depth of the subsoil drainage trenches was 5 m, having concrete base and firm sides. These drainage pipes were installed under a new road foundation.

Syntex GNP B1 is a medium weight nonwoven geotextile which acts as an excellent filter, allowing subsurface water to pass into the drainage core while preventing adjacent soil from clogging the system.

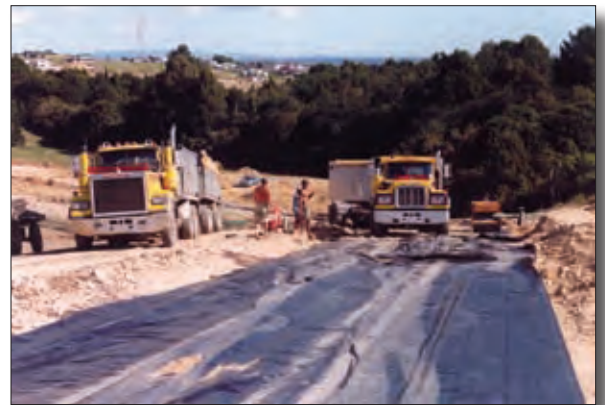
**S**yntex GW 165 woven geotextile was used as a base for road construction in a new subdivision development in Manukau. The clayey subgrade was properly compacted and a layer of Syntex GW 165 was laid directly over the subgrade. This was overlaid by approximately 150-300 mm GAP 40 base layer and 150 mm of concrete. The “separation” function of this economical high strength woven geotextile prevented the aggregate from becoming contaminated with the subgrade soils below.

The Syntex GW 165 was rolled out loosely, without wrinkles and folds and placed in direct contact with the soil. The geotextile was covered with approximately 150 to 300 mm of loosely placed GAP 40 mm aggregate prior to compaction. The aggregate was back bladed into place to form a slight mound in the middle and to extend out beyond the fence line. This was then rolled with a vibrating roller before putting 150 mm of concrete surface layer on to it.

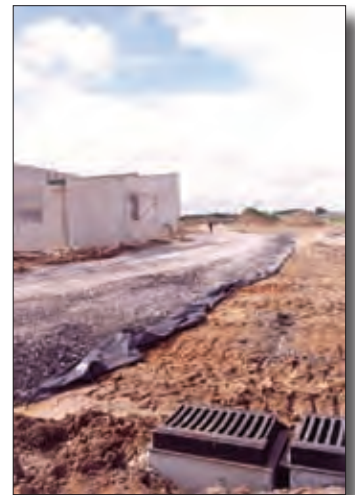
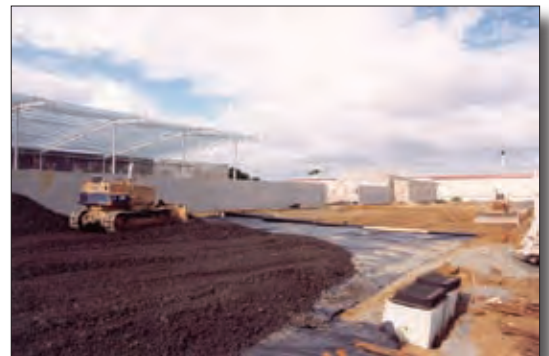
Syntex GW 165 was laid on the existing volcanic ash subgrade before putting 300 mm of gravel rock overlaid with GAP 60 to a depth of 100 mm. After proper compaction, 40 mm of hot mix was spread on the top. Over 17,000 m<sup>2</sup> of geotextile was successfully installed on this site.

By unrolling a high modulus Syntex GW 165 woven geotextile directly on the subgrade during construction, aggregate is permanently separated from finer soils below.
